CALLCOTT & DOWNEY

Topic: Air bleeding a hydraulic cylinder by allowing the cylinder rod to free-travel.

Potential hazard alert!

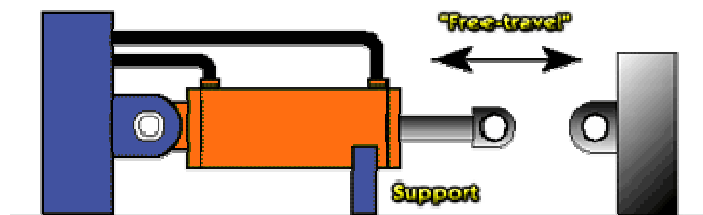
This is what is meant by cylinder rod "free-travel":

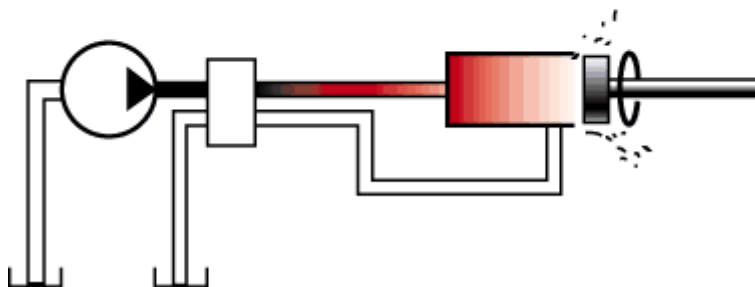
Air in transmission lines can cause an extreme safety hazard!

When he activated the directional control valve to extend the cylinder rod, there was no immediate response. After a few seconds, the rod began to move. It picked up speed rapidly, and continued moving even after he shut the oil flow off.

The rod literally blew out of the end of the cylinder, shearing the four tie-rod bolts.

An investigation into the cause of this accident determined that the pump flow entering the air-bound transmission lines, compressed the air ahead of the oil. When the pressure overcame the initial resistance to move the cylinder rod, the compressed air expanded, causing the cylinder rod to accelerate at high velocity.

These are not isolated cases by any means, so exercise extreme caution when air-bleeding a cylinder. It is safer to air-bleed a cylinder when both the closed-end and rod-end are securely fastened to their respective clevis anchor points.

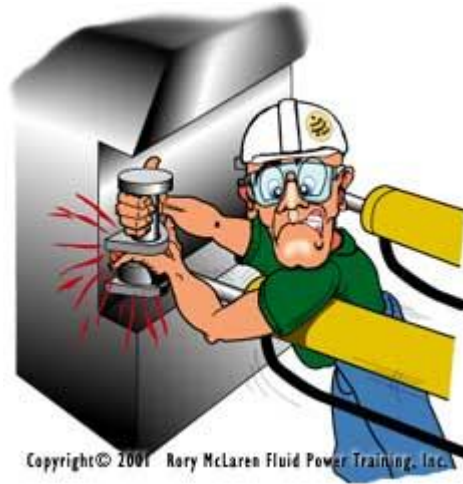
As the cylinder rod clevis neared the anchor point, he signaled to the helper to pause. He needed to rotate the rod-eye slightly to align it with the anchor. He placed his hand over the end of the rod-eye to guide it, and used a pry-bar to rotate the rod.

As he placed leverage on the rod with the pry-bar, the rod assembly unexpectedly lunged forward, pinning his hand in-between the rod-eye and the frame anchor. The accident claimed four of his fingers.

An investigation into the cause of the accident determined that the trapped air in the cylinder caused the cylinder rod to travel erratically.

When the assembly-line worker paused to align the rod-eye, the oil pressure compressed the air. However, the pressure generated by the compressed air was not sufficient to overcome the initial resistance that was needed to overcome seal resistance.

The action of rotating the rod with the pry-bar generated the force needed to overcome seal resistance, and the pressure generated by the compressed air caused the cylinder to move unexpectedly.

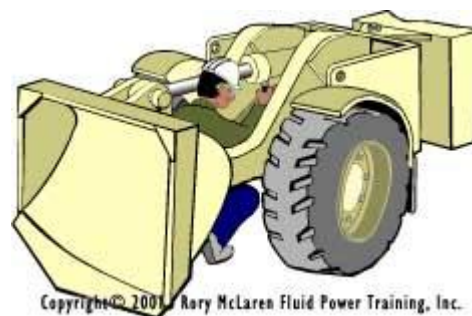
As it stopped, the left-hand cylinder rod immediately extended. However, it appeared to travel at a much greater speed, and it did not stop!

When he activated the directional control valve lever to extend the cylinder rods, the right-hand rod traveled its full stroke and stopped.

The entire rod assembly shot out of the cylinder and tumbled into the front-frame assembly. The giant rod weighed an estimated 800 lbs.

This incident was never investigated as an accident. However, it was determined that the root-cause of the original problem was that the nut that fastened the rod to the piston had worked loose and unscrewed.

When the mechanic attempted to purge air from the cylinders, the system pressure ejected the cylinder rod from the cylinder tube.
